Debris/Ice/TPS Assessment and Integrated Photographic Analysis of Shuttle Mission STS-91

**DEBRIS/ICE/TPS ASSESSMENT
AND
INTEGRATED PHOTOGRAPHIC ANALYSIS
OF
SHUTTLE MISSION STS-91**

2 June 1998

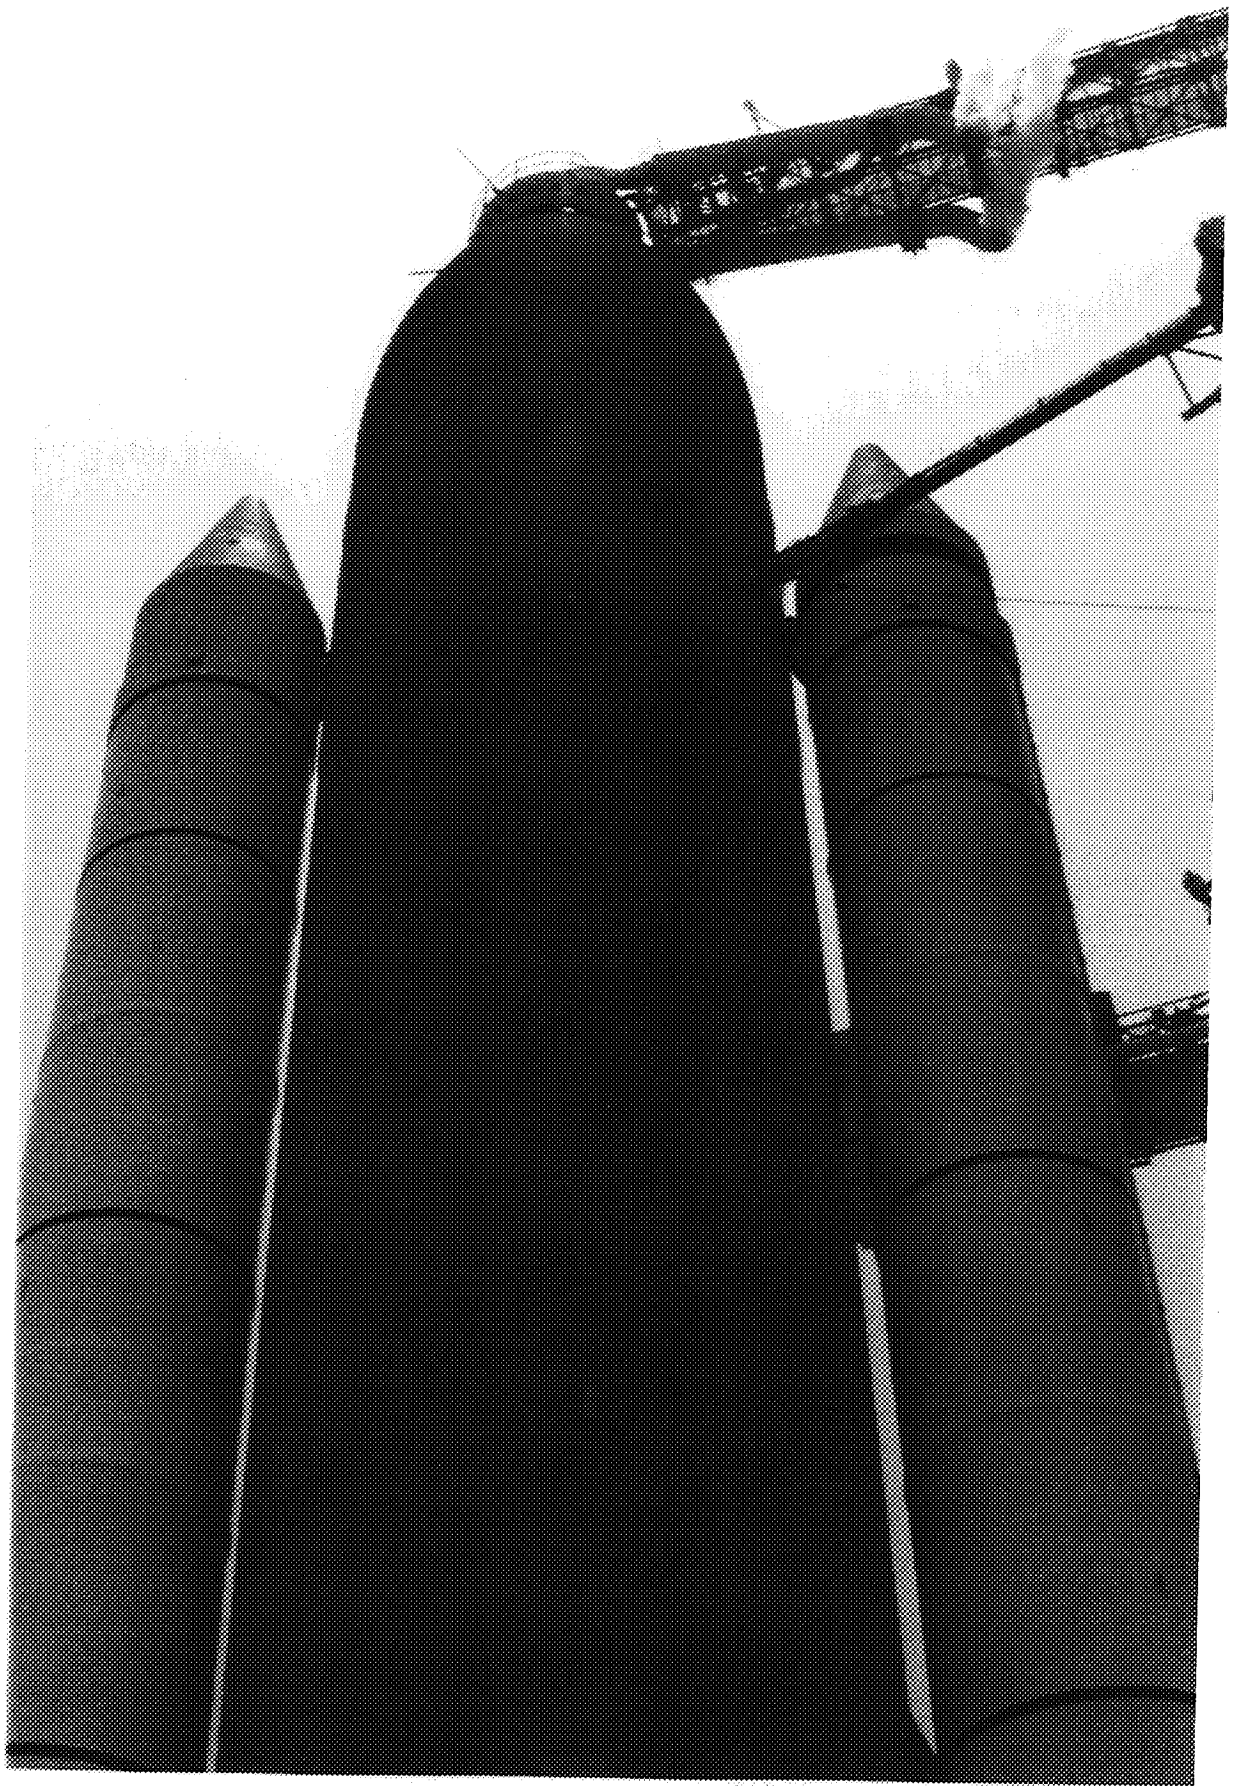
Photo 7: SLWT -Z Side

No anomalies were detected on the -Z side of the SLWT after cryoload.
Note black composite flight door and sanded stringer heads/valleys on the intertank.

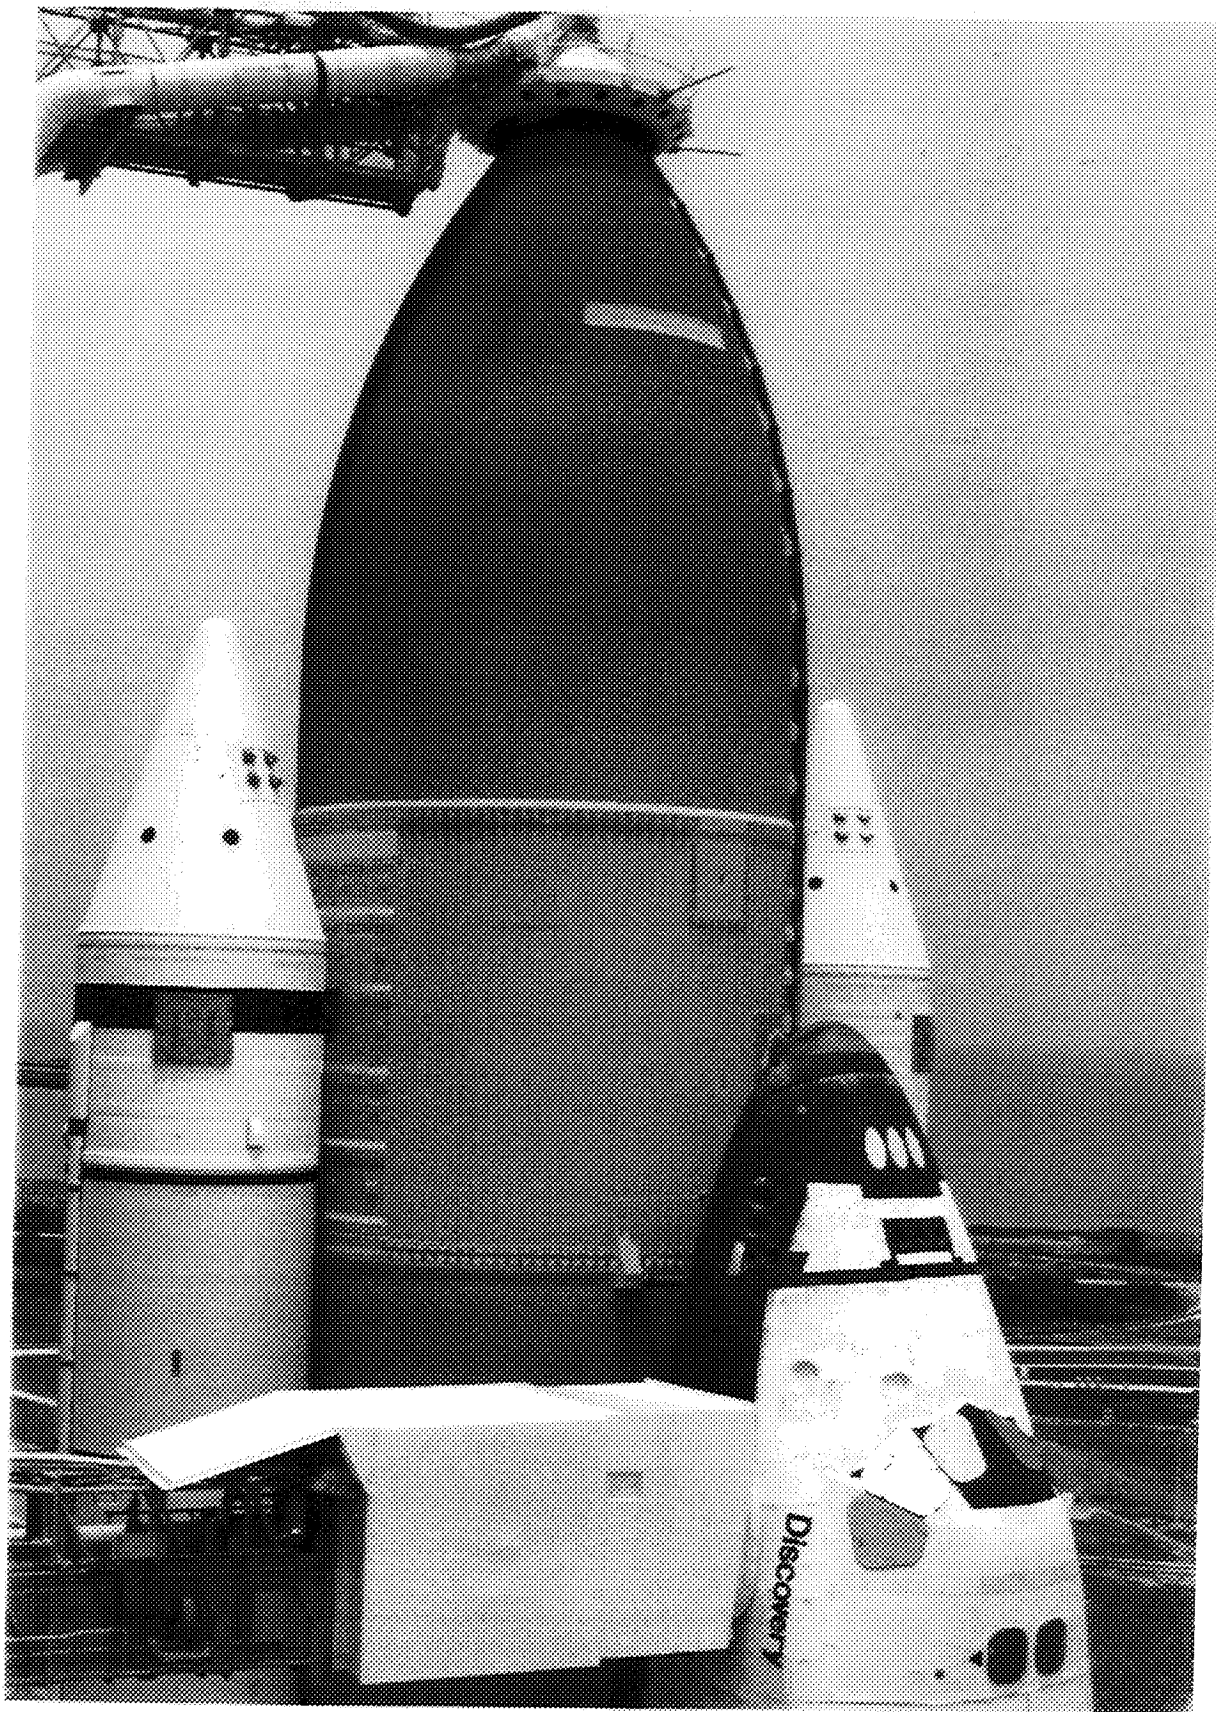
Photo 8: LO2 Tank After Cryoload

The Thermal Protection Systems performed nominally during the tanking test. The Final Inspection Team observed very light condensate, but no ice or frost accumulations, on the LO2 tank acreage. TPS surface temperatures ranged from 69 to 88 degrees F depending on sunlit or shadowed areas.

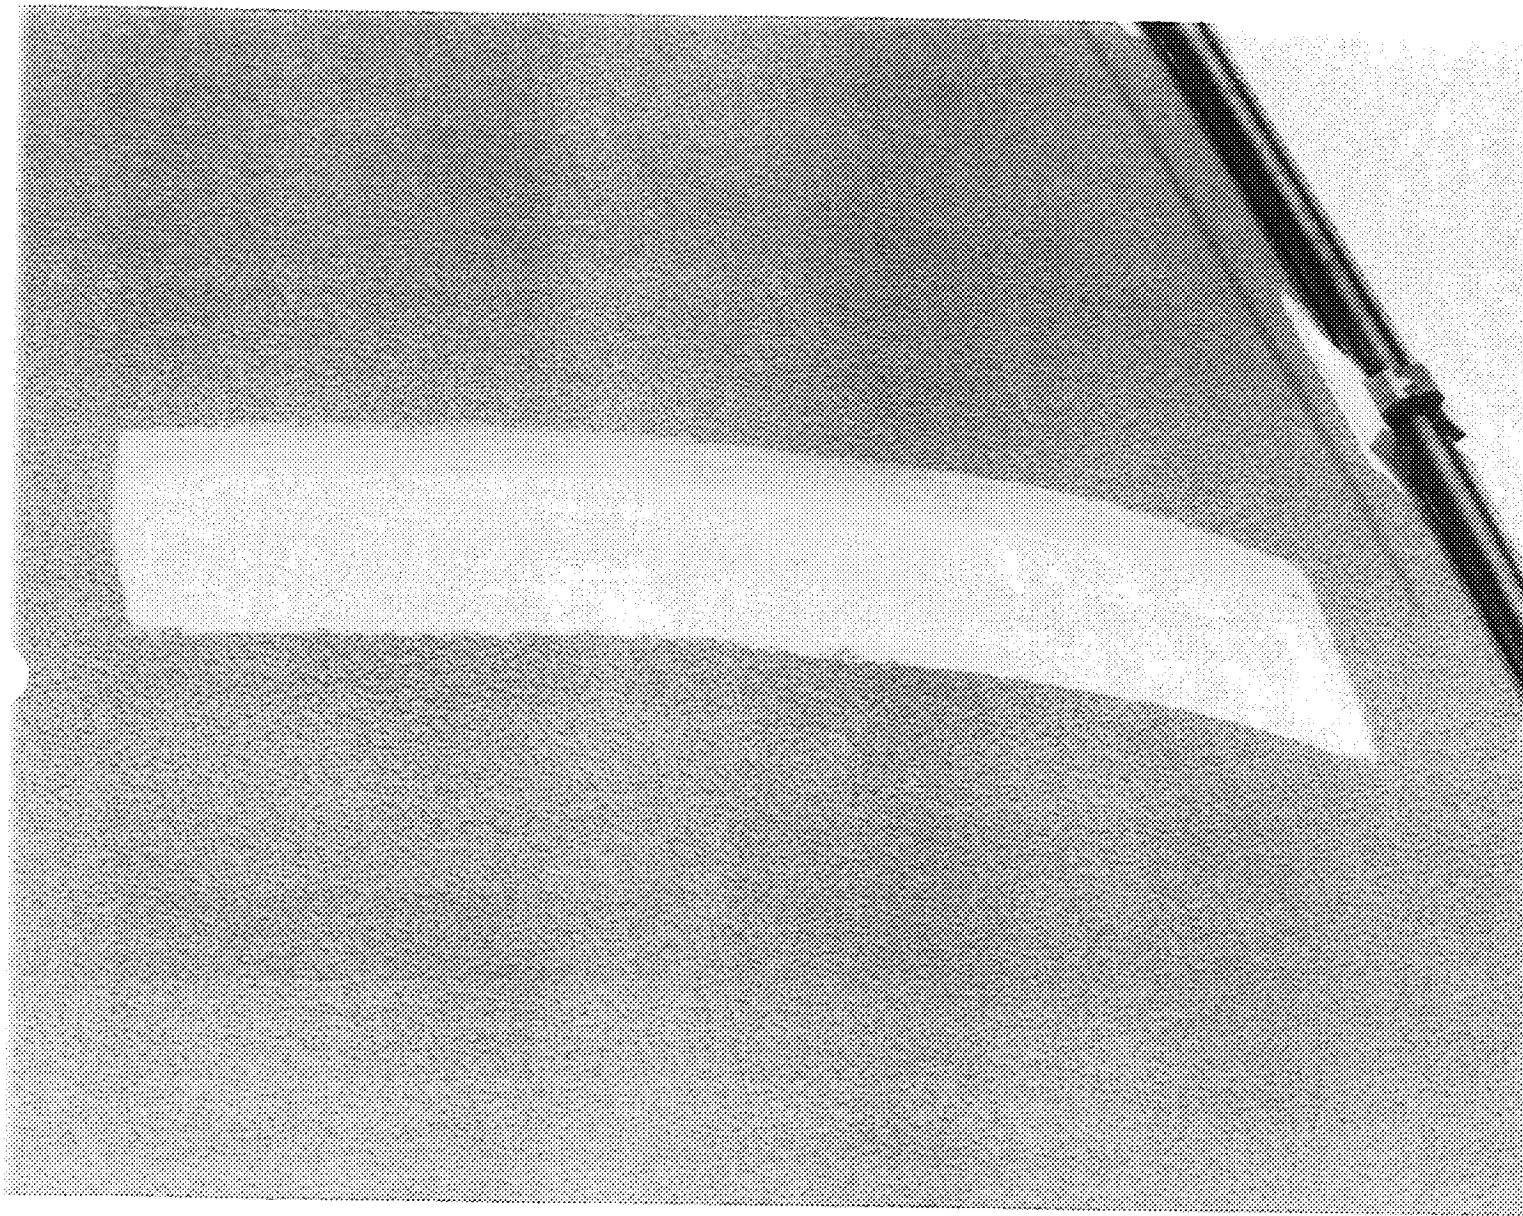
Photo 10: +Z Side Sanded Area

The sanded area on the LO2 tank ogive exhibited no anomalies and averaged 4 degrees Fahrenheit less (as measured by the infrared radiometer) than the adjacent acreage foam. No ice, frost, or condensate accumulations were detected.

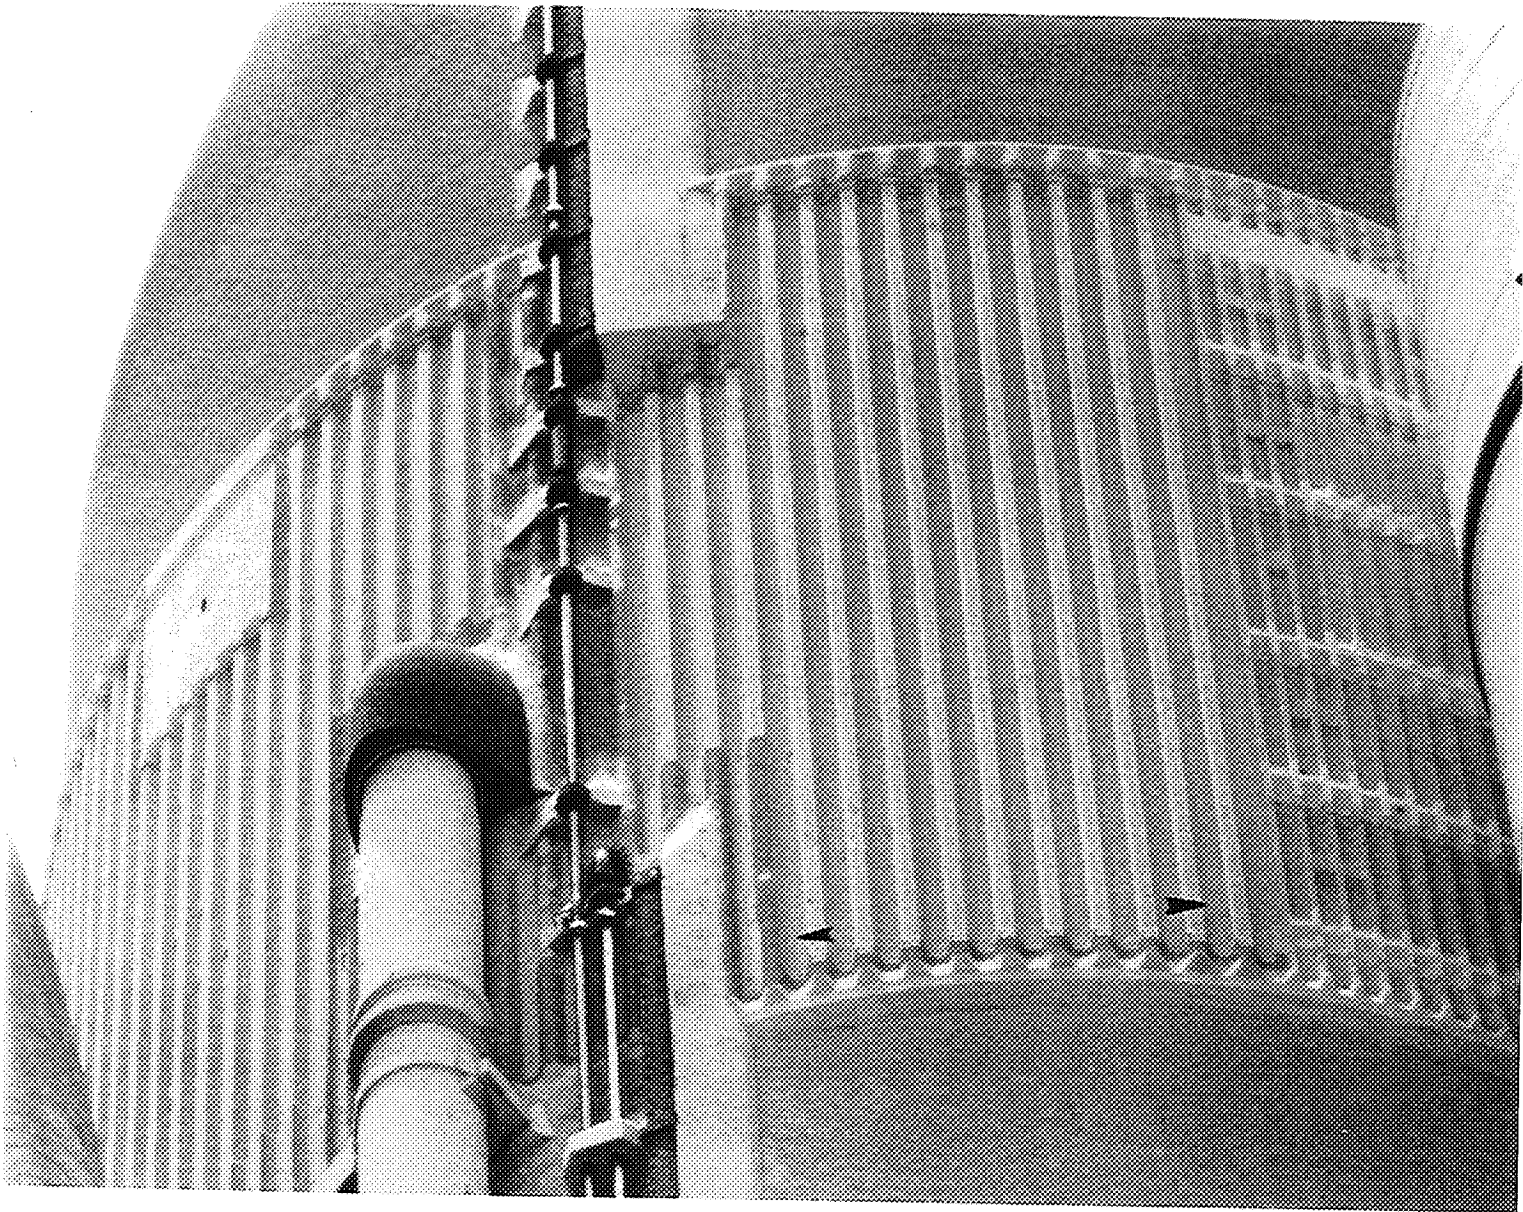
Photo 11: Intertank Stringers

Two cracks were detected in the +Y+Z quadrant of the intertank. One crack was located in the second stringer valley in the +Y direction from the PAL ramp; the second crack was located in the second stringer valley in the +Z direction from the +Y thrust panel (arrows). The cracks appeared to originate from the as-sprayed foam at the aft end of the stringers extending forward approximately 7 inches from the LH2 tank splice. Each crack was no greater than 1/16 inch wide with no visible offset or ice/frost formation. Although the NSTS-08303 Ice/Debris Inspection Criteria documents an intertank TPS crack in the -Y-Z quadrant as acceptable for flight, no such case was available for cracks in the +Y+Z quadrant. Consequently, an IPR was taken to determine this condition was acceptable for flight as well.

The two 7-inch cracks in the intertank stringer valley foam had closed completely.

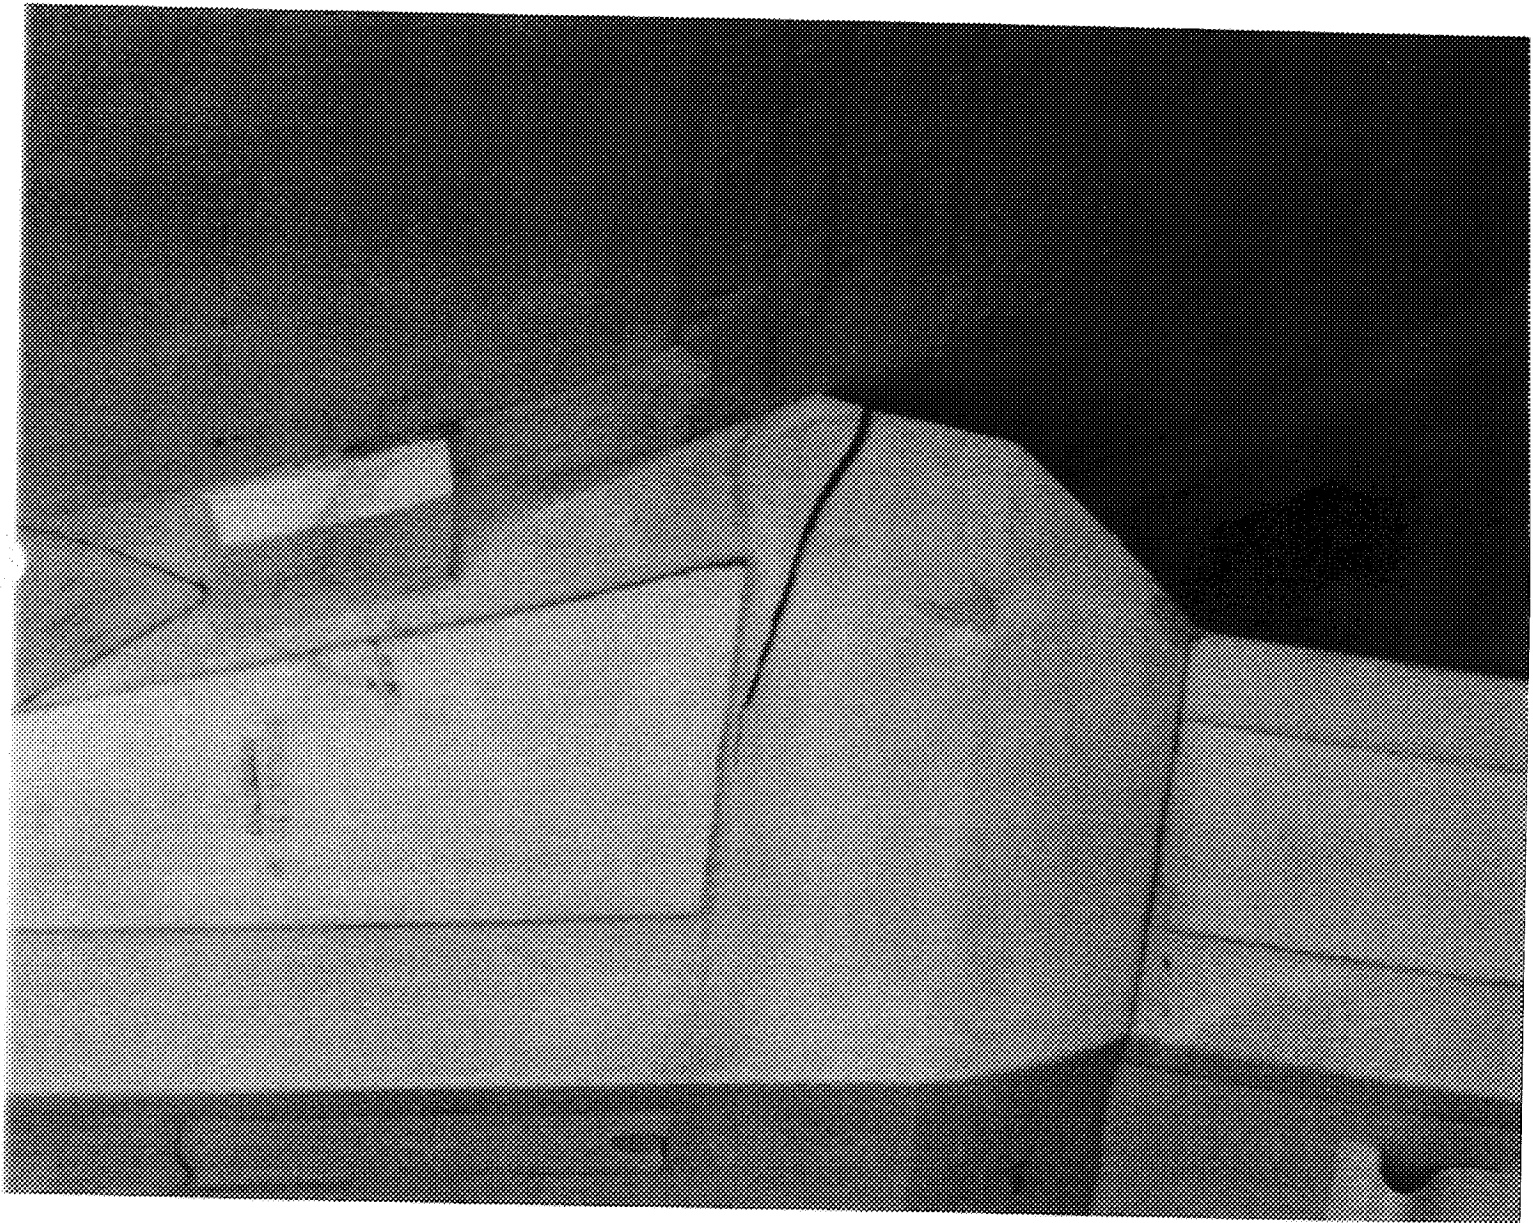
Photo 13: -Y Vertical Strut

A 10-inch long by $\frac{1}{4}$ -inch wide stress relief crack had formed, as expected, on the -Y vertical strut forward facing TPS.

The dimensions of the stress relief crack in the -Y vertical strut had not changed. No crushed foam in the LO2 feedline brackets could be seen from the MLP deck. The sanded area on the LO2 tank ogive exhibited no ice formations or foam damage.

As expected, the stress relief crack on the -Y vertical strut had closed to a barely discernible hairline crack. This condition is acceptable for flight per the NSTS-08303 criteria.

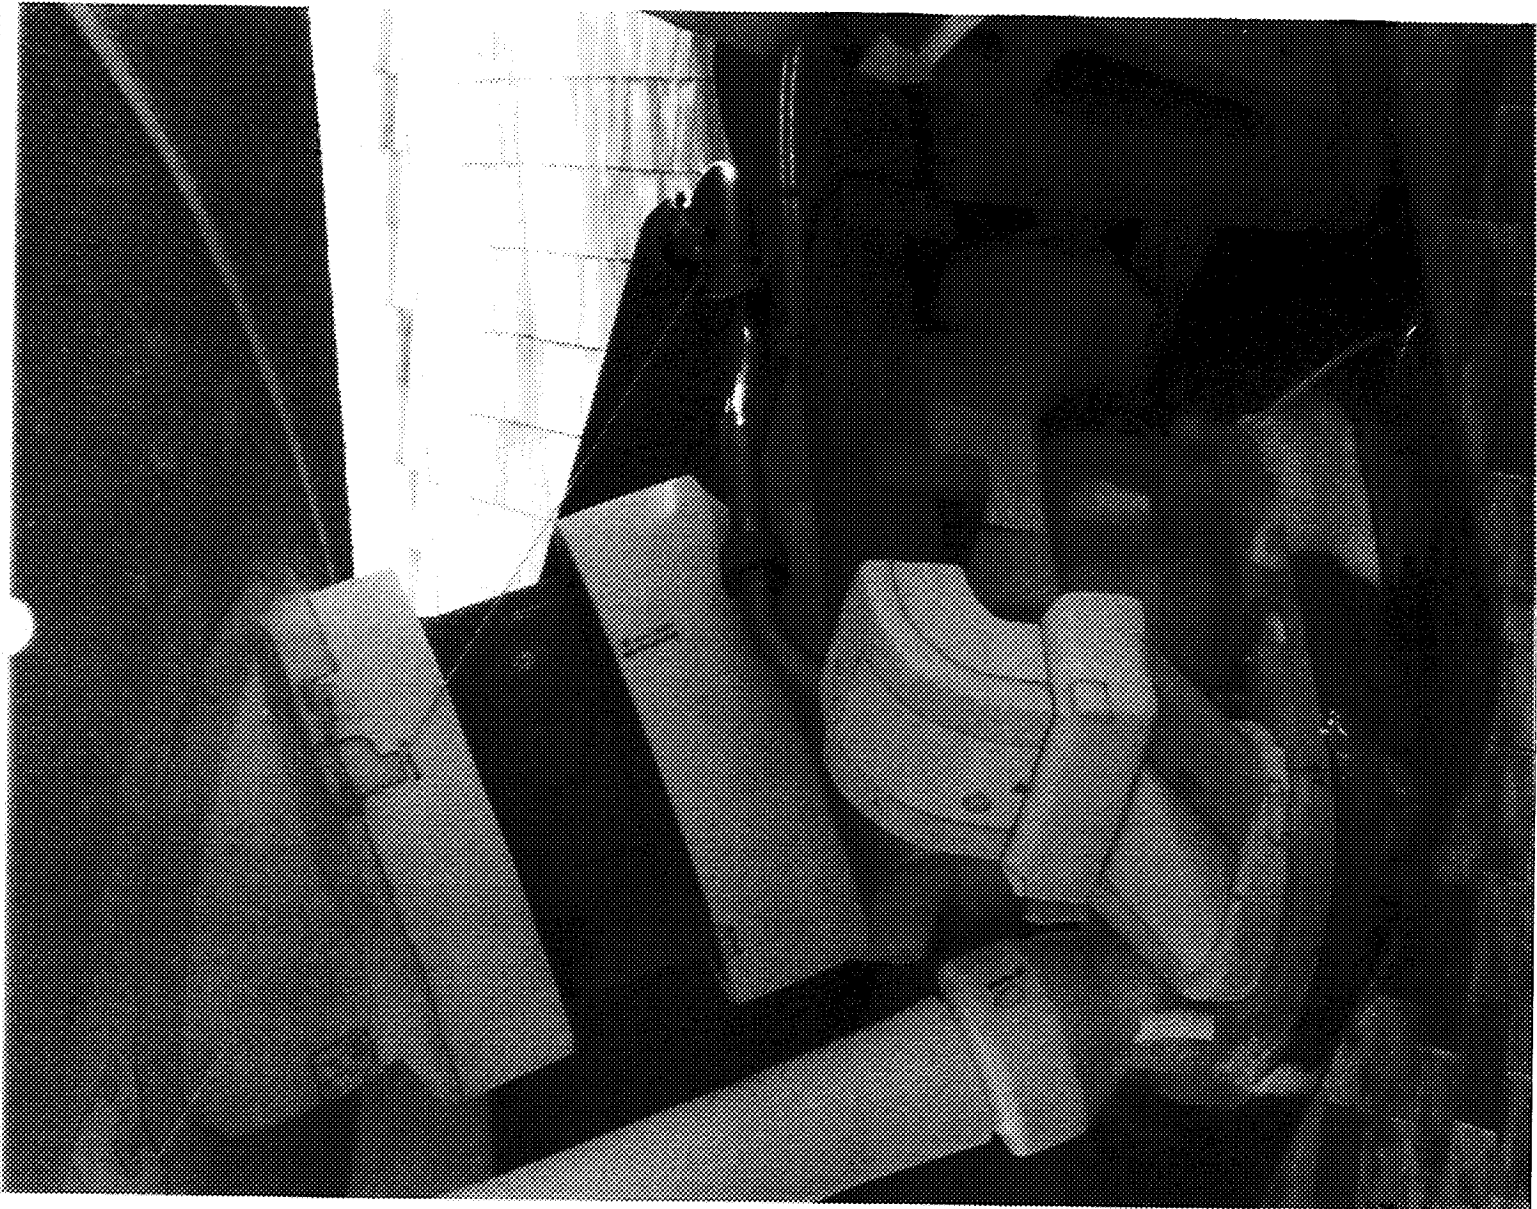
Photo 14: LH2 ET/ORB Umbilical

Typical amounts of ice/frost had accumulated on the LH2 ET/ORB umbilical purge barrier outboard side and forward surface. Typical ice/frost fingers were present on the pyro canister and plate gap purge vents. No unusual vapors or cryogenic drips had appeared during tanking and stable replenish.

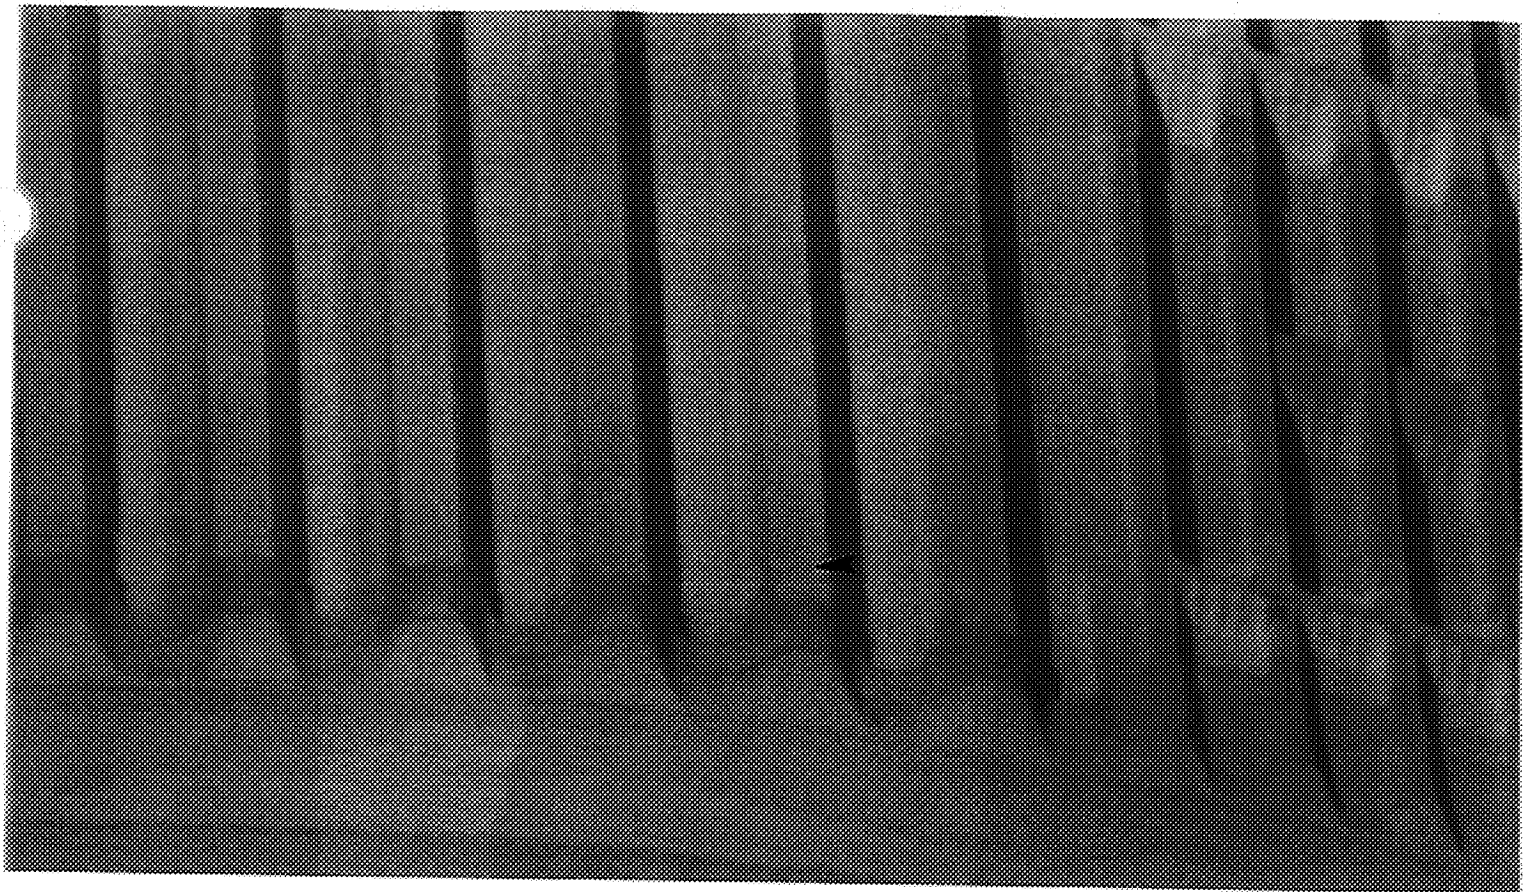
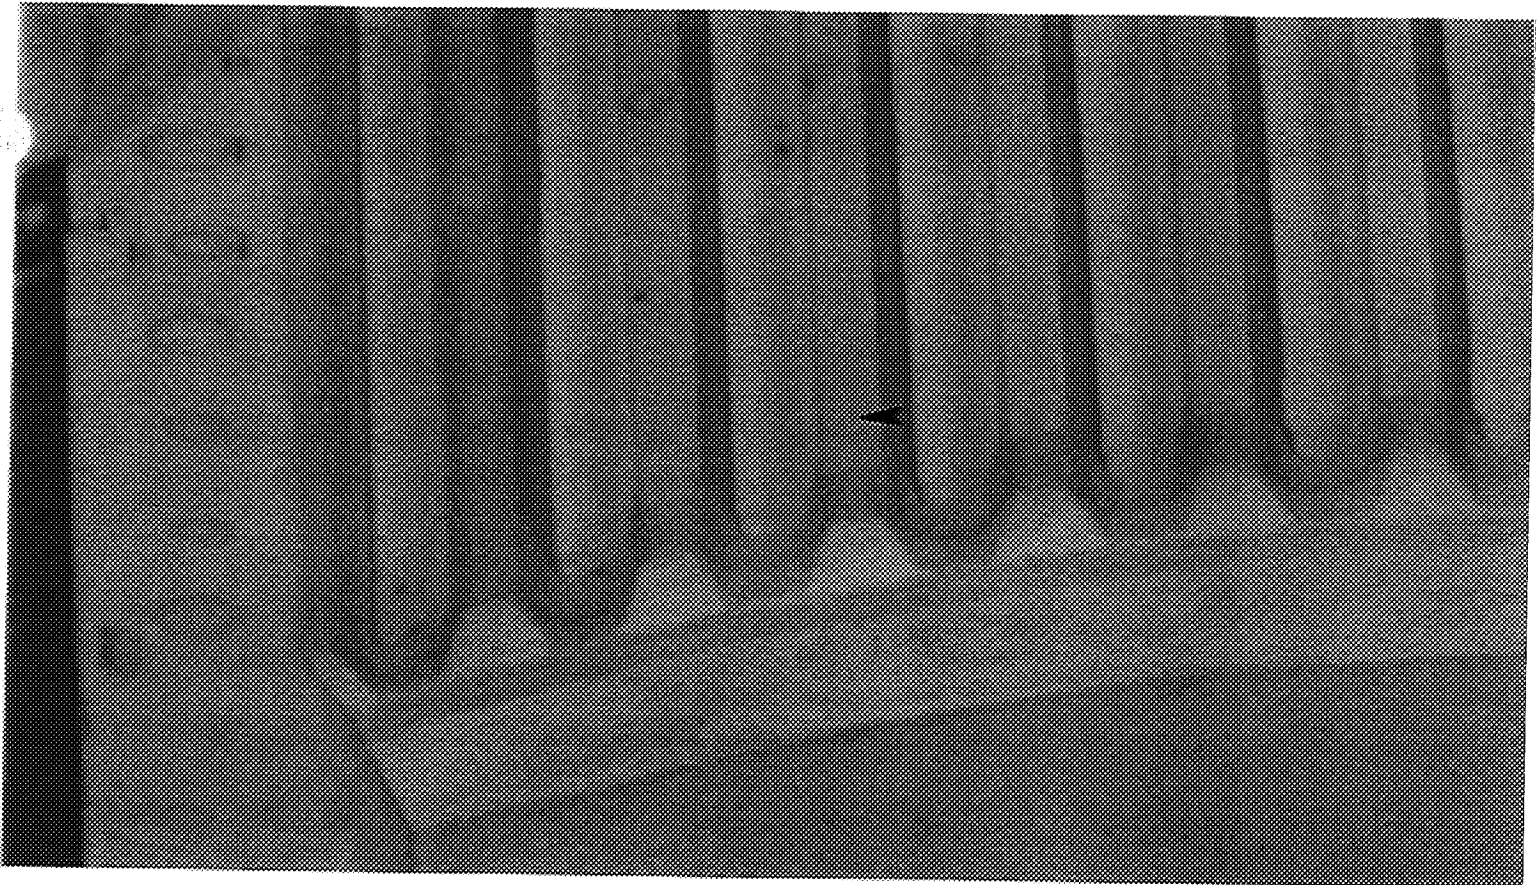
Photo 18: Intertank Stringer Foam Cracks

The two 7-inch cracks in the ET intertank stringer valleys (+Y+Z quadrant), had closed to barely visible hairline cracks. The IPR taken during the tanking test was upgraded to a PR with an MRB to use as-is rationale.

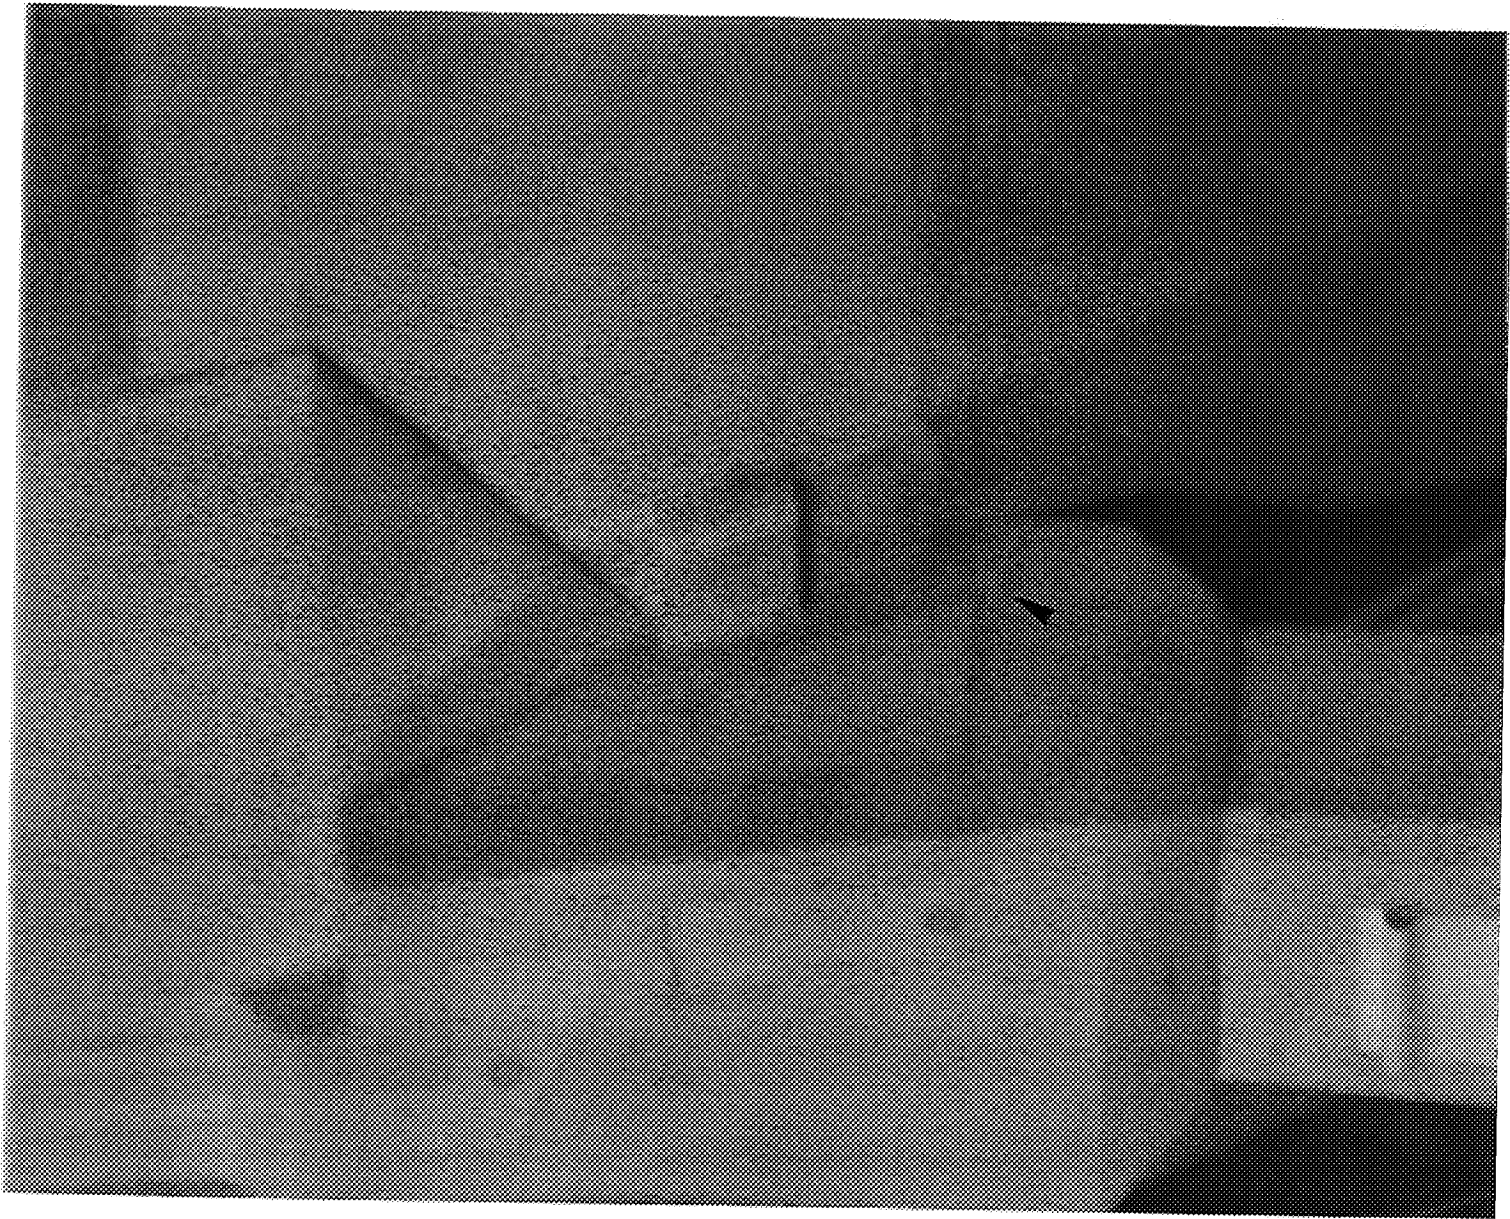
Photo 19: -Y Vertical Strut

The size of the stress relief crack in the -Y vertical strut had not changed during drain

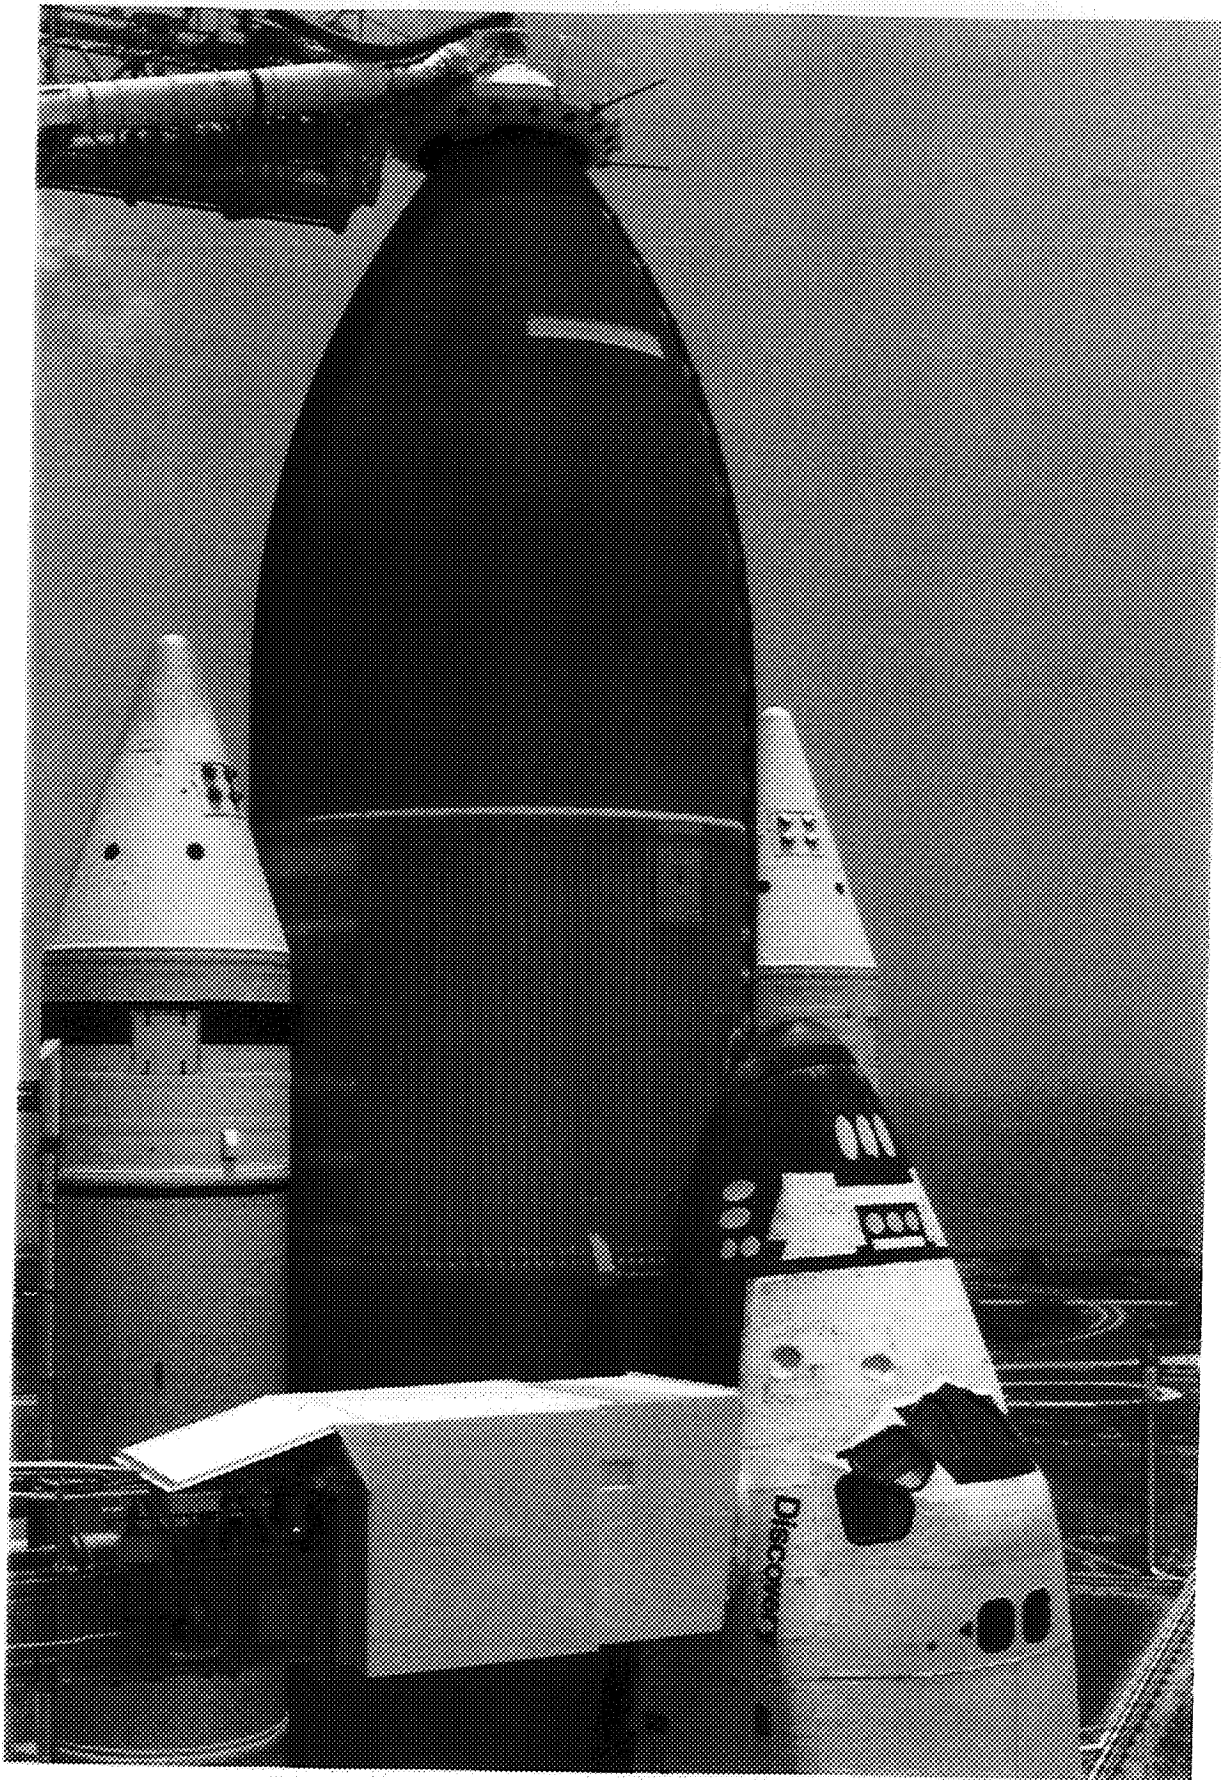
Photo 21: LO2 Tank After Cryoload

The Final Inspection Team observed very light condensate, but no ice or frost accumulations, on the LO2 tank acreage. TPS surface temperatures ranged from 82 to 92 degrees F. Note configuration change to the intertank stringer heads and valleys, which have been sanded.

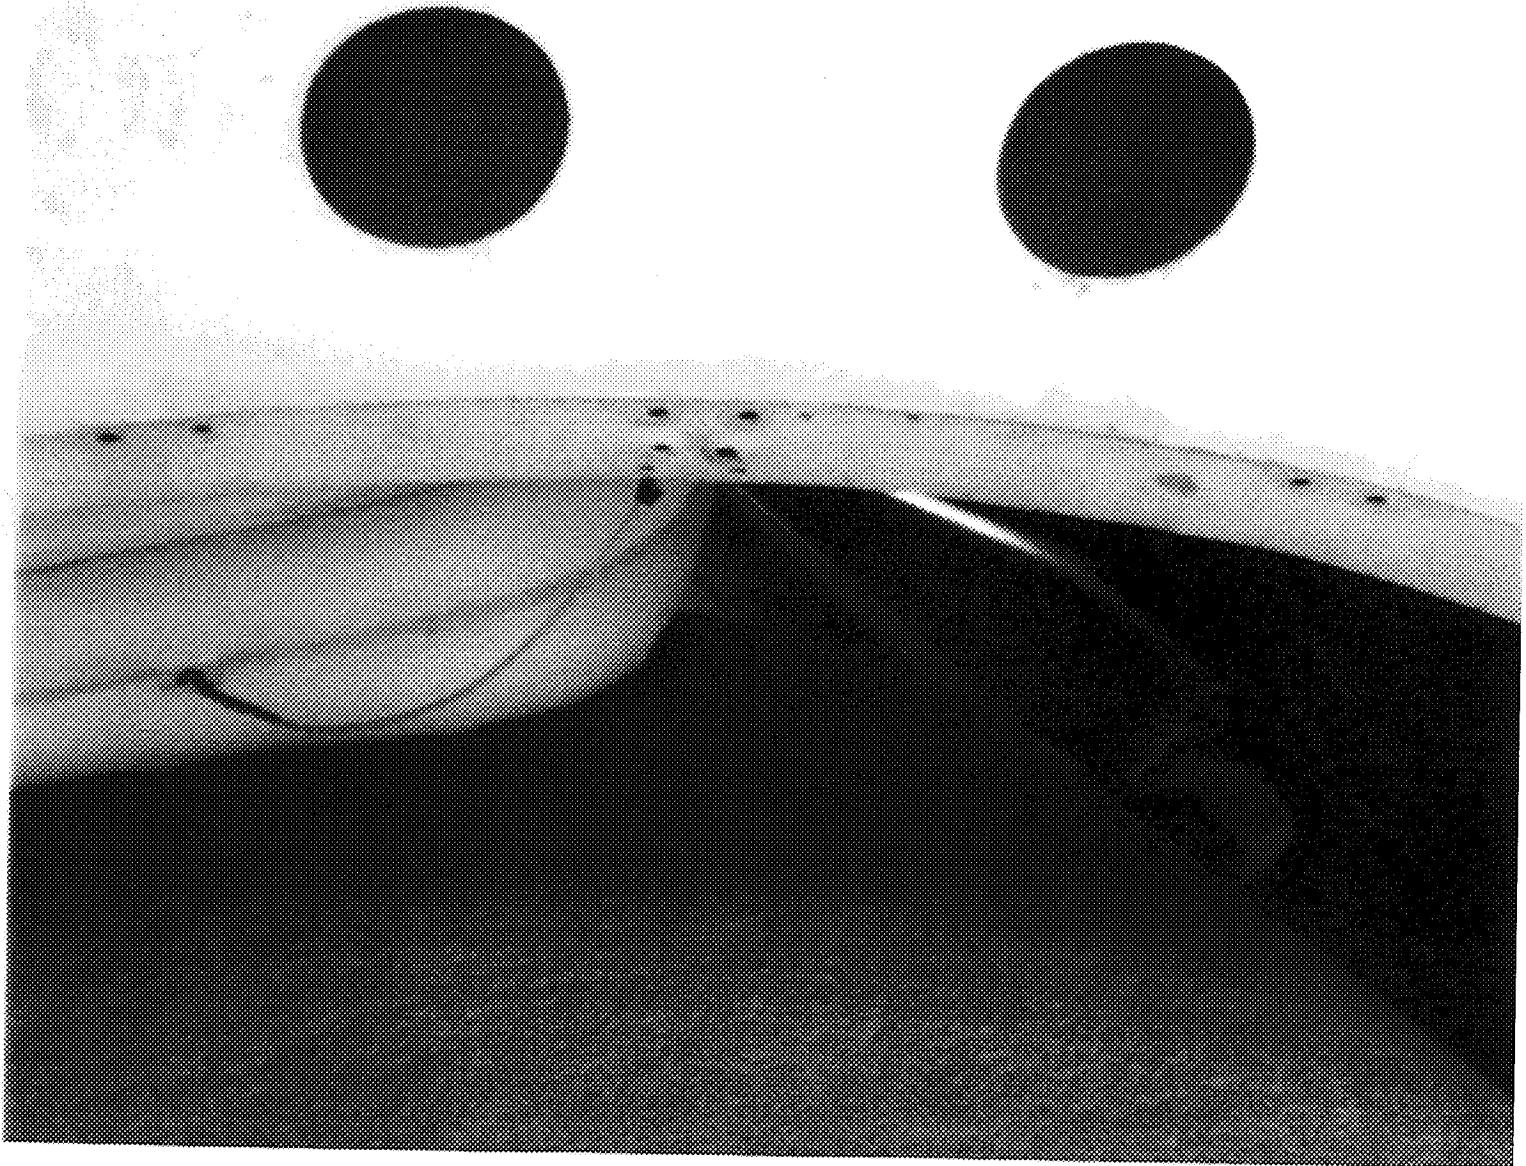
Photo 22: Composite Nose Cone

Light condensate was visible on the composite nose cone between the fairing
and the southwest louver

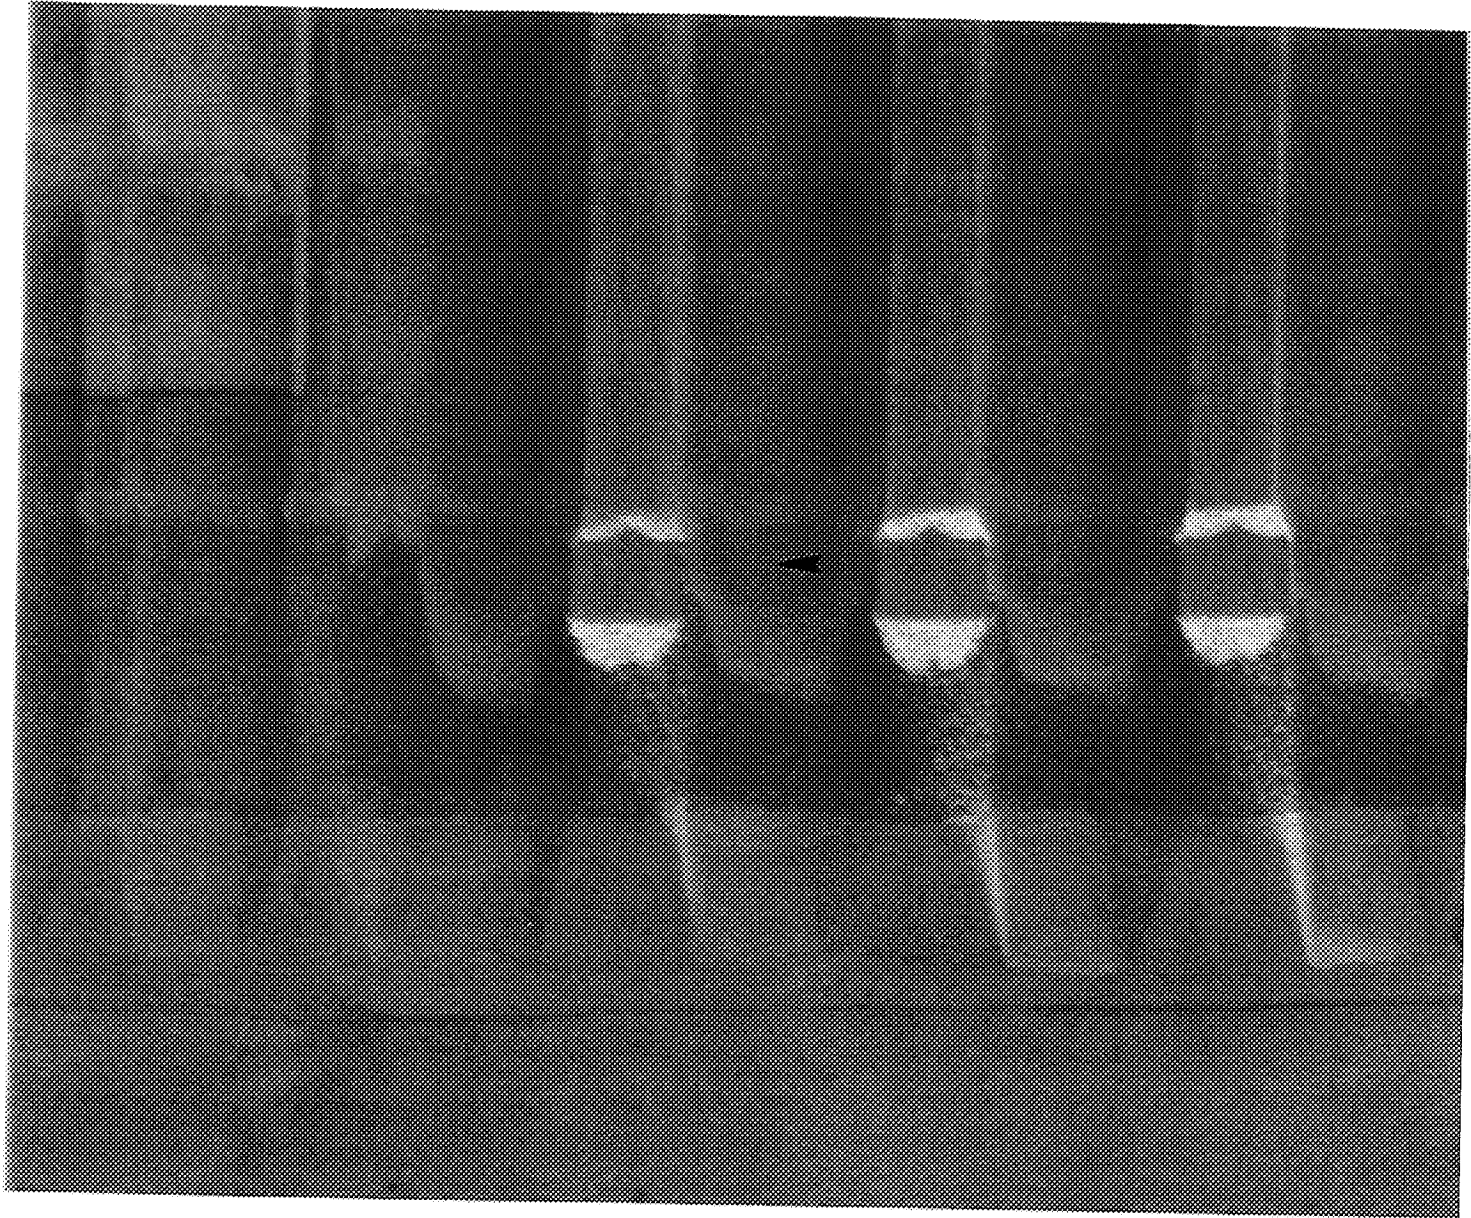
Photo 24: Cracks in Intertank Foam

Two small cracks were detected in the +Y+Z quadrant of the intertank. The cracks appeared to originate from the as-sprayed foam at the aft end of the stringers extending forward approximately 7 inches from the LH2 tank splice. These two cracks had been documented during the tanking test. Two new, similar cracks were detected. A 4-inch crack was located in the -Y+Z quadrant and a 6-8 inch crack was located in the -Y-Z quadrant. All four cracks were no greater than 1/16 inch wide with no visible offset or ice/frost formation and were acceptable for flight per the NSTS-08303 criteria and tanking test PR rationale.

Small cracks, ranging in length from 4 to 8 inches, were detected in three of the four intertank quadrants in stringer valleys near the LH2 tank-to-intertank flange closeout. The cracks appeared to originate from the as-sprayed foam at the aft end of the stringers extending forward from the LH2 tank splice.
